Evaluation Report 180

Edwards Model GN-R78-436 (11.1 m) Rod Weeder

EDWARDS MODEL GN-R78-436 ROD WEEDER

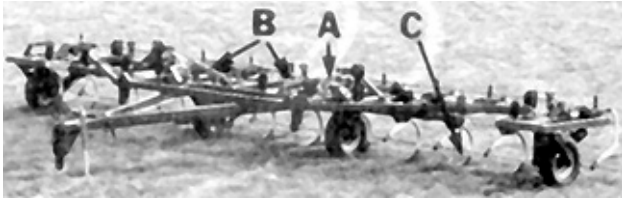
FIGURE 1. Edwards GN-R78-436: (A) Master Cylinder, (B) Wing Lift Cylinders, (C) Cultivator Shanks.

Detailed specifications are given in APPENDIX I while FIGURE 1 shows the location of major components.

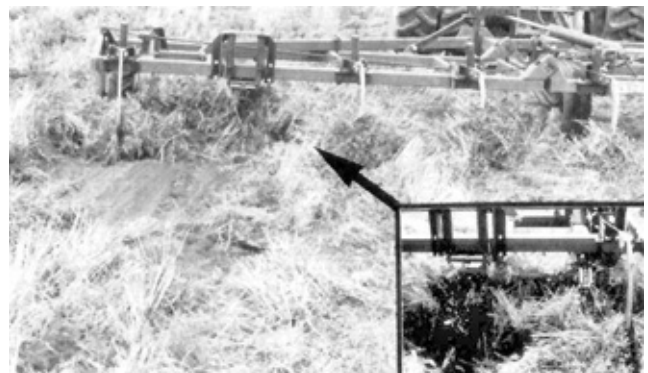
Plugging: The Edwards GN-R78-436 cleared trash well in medium to heavy straw conditions. Occasional plugging at the wing section drive shafts (FIGURE 4), occurred due to reduced rod to drive shaft clearance when damp trash and weeds wrapped around the rod shanks and drive shafts.

FIGURE 4. Plugging at the Wing Section Drive Shafts.

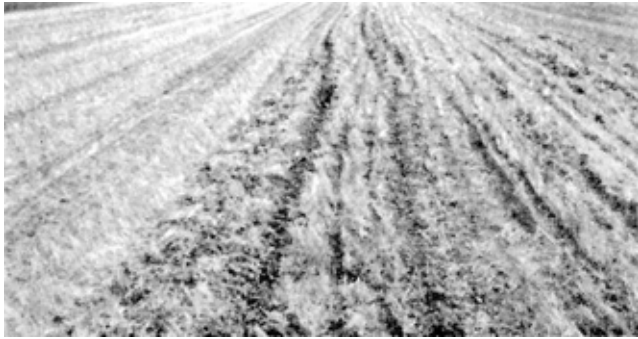
Trash Burial and Surface Condition: The Edwards GN-R78-436 buried less trash than most heavy duty cultivators and slightly more

than most blade cultivators (FIGURE 5). In secondary tillage the Edwards GN-R78-436 left a smooth, even, unridged soil surface.

FIGURE 5. Trash Burial with Blade Cultivator (left) and Edwards GN-R78-436 (right).

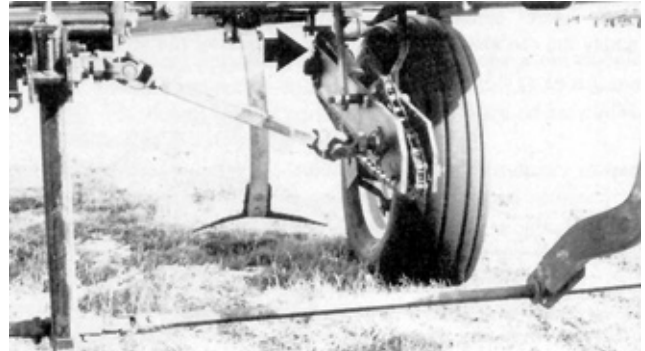
For high transport speeds or long transport distances, removal of the centre drive assembly (FIGURE 8) was recommended. Disengaging the assembly was inconvenient as the operator had to climb over the rod weeder frame. Pins were provided to lock the assembly for both field and transport positions.

FIGURE 8. Centre Drive Assembly in Transport Position.

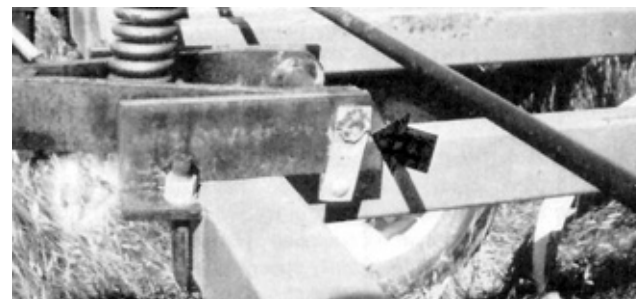
- All rod support brackets were worn and reversed at	67	482
- A rod shank holder bent, necessitating replacement at	101	727
- The weld on the locking bars on two rod shank swivels cracked and were rewelded at	115, 1 55	828, 1116

Shanks: The weld failed and several rod shank holders bent (FIGURE 12) as a result of insufficient shank lift to clear field obstructions. Bending of the centre section rod drive shank holder (FIGURE 13) caused interference and wear of the overlapping right and centre section rod ends. The weld on two rod shank swivel locking bars cracked (FIGURE 14) and had to be rewelded.

FIGURE 14. Weld Failure on a Rod Shank Swivel Locking Bar.

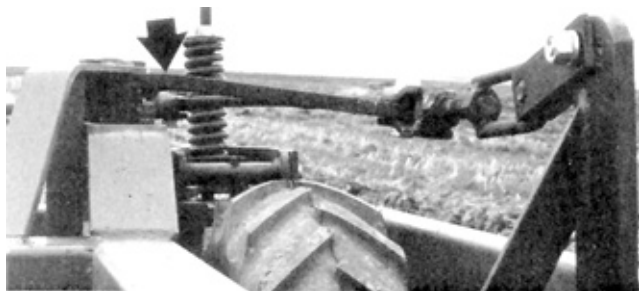
- The depth control pivot arms bent at	10	72
- Interference of the depth control lock-up bracket and a rod shank holder was corrected at	12	86
- Interference between the centre and right depth control rods was corrected at	12	86

Depth Control Pivot Arms: The depth control pivot arms bent (FIGURE 15) as a result of tillage depth adjustment during field operation. After initial bending no further problems were encountered. Depth control and adjustment were unaffected by the bent members.

FIGURE 15. Bent Depth Control Pivot Arm.
